Trouble-shooting program

With these instructions it is possible to check all Mercedes-Benz passenger cars of type W 124 with standard-equipment automatic electronic heating system.

Rapid diagnosis chart for automatic electronic heating system (Duo-Heizmatik)
 Test adapter KDHK 0001 with adapter lead KDHK 0009

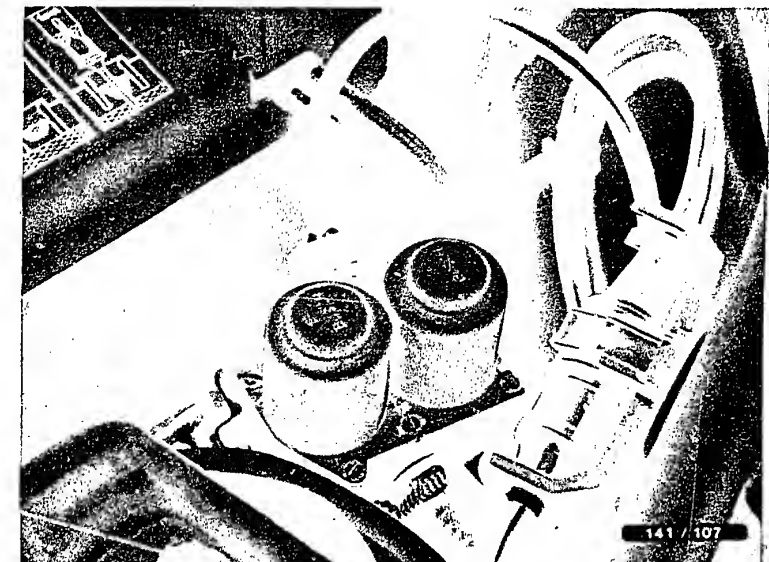
The duo heating-water valve is in the so-called equipment space on the right-hand side (as viewed in the forward direction of travel) in front of the battery (see top picture).

Heating-water pump (not installed in 200 and 230E with manual transmission) is in the engine compartment on the right-hand side as viewed in the forward direction of travel (see bottom picture).

The additional blower for air admission to the passenger-compartment temperature sensor is installed under the glove compartment insert (center picture).
